An investigation into water leakage of concrete balconies in residential apartment buildings

August 2024

Swinburne University of Technology (SUT) has, with the support of the Housing Industry Association (HIA), conducted a research project to identify the causes of water leakage through concrete balconies in Class 2 buildings.¹

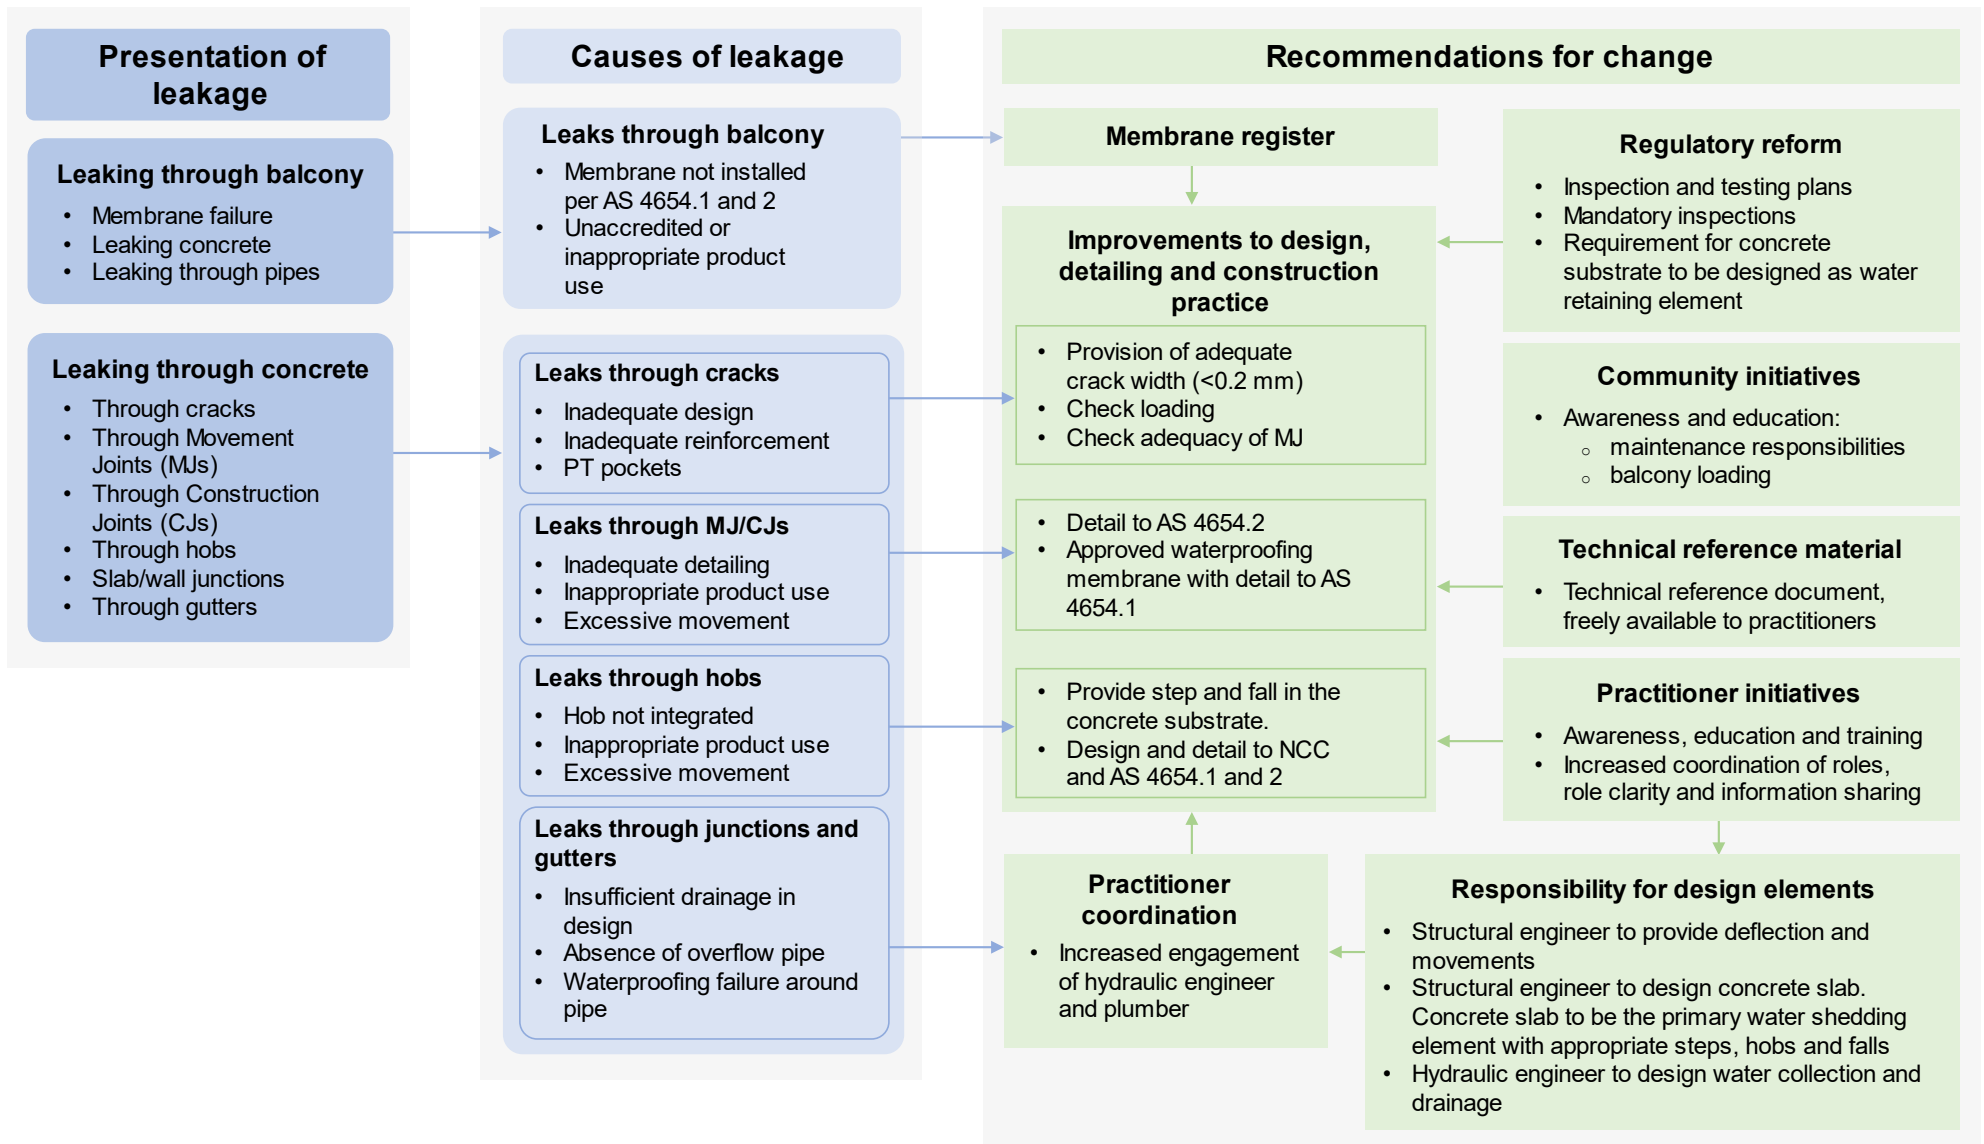
Figure 1: Presentation and causes of water ingress to concrete balconies, and a summary of proposals to minimise the occurrence of leaks.

Figure 1 summarises the key issues identified by this research, and the associated recommendations for change.

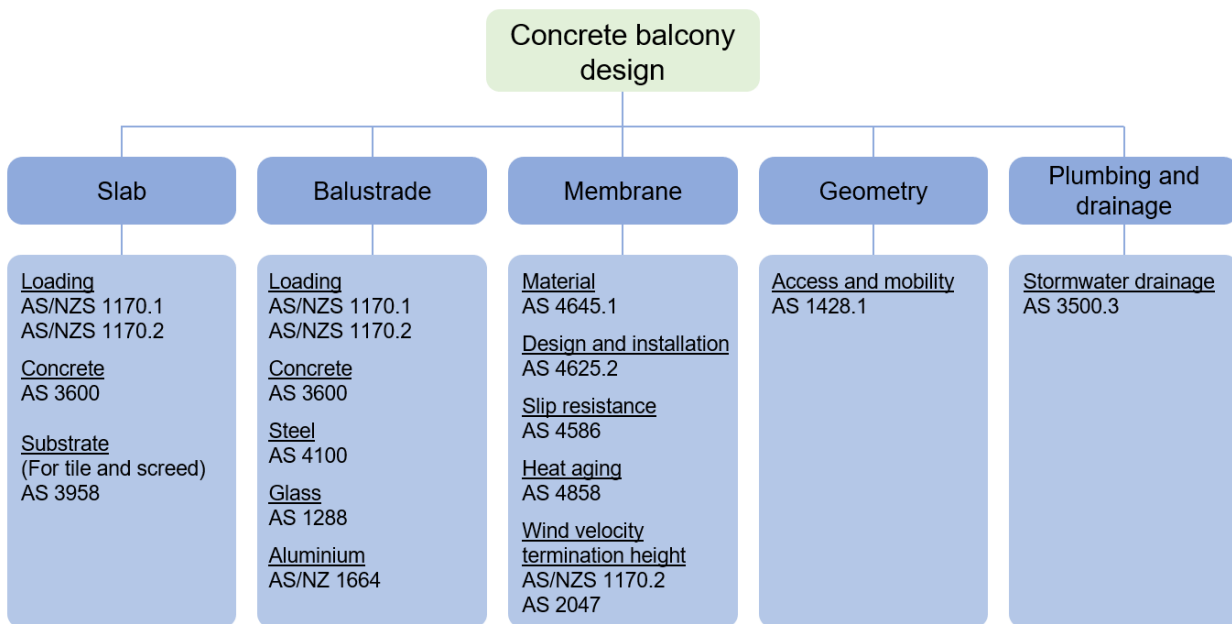
Figure 4: Australian Standards relevant to concrete balcony construction

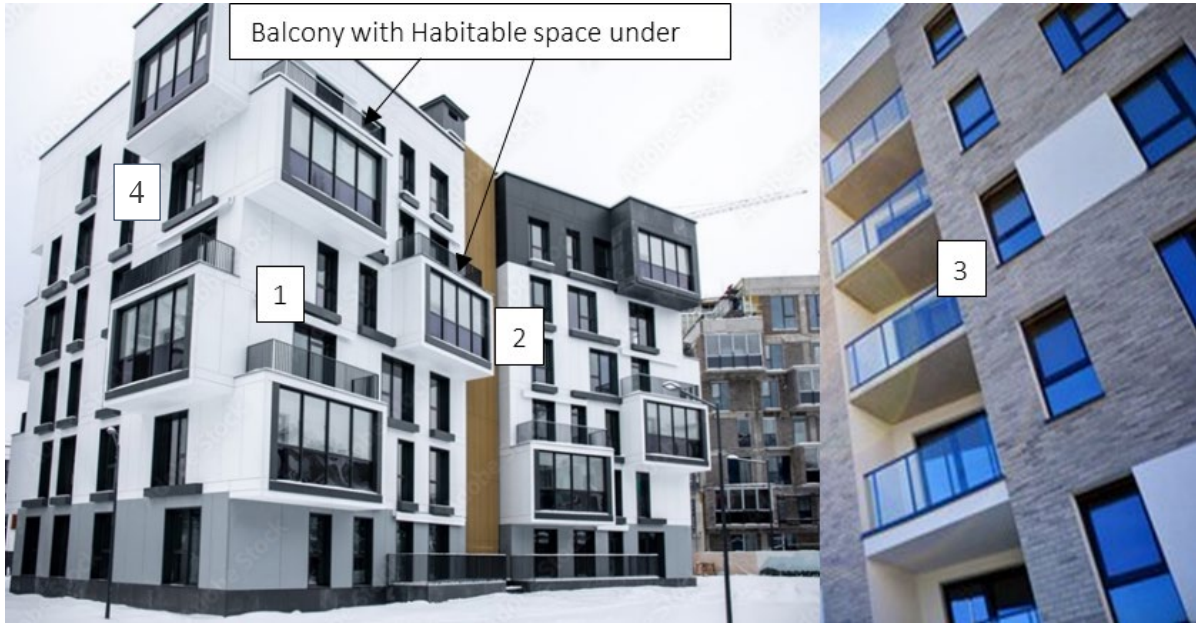
Figure 8: Balcony Types within the scope of this research

1. Projecting open balconies. This type of balcony projects outward from the structure's exterior wall, but has no roof or windows.
2. Projecting enclosed balconies. This type of balcony projects outward from the structure's exterior wall, and has a roof and windows (which can be closed or openable).
3. Recessed/inset open balconies. This type of balcony is inserted into the structure's exterior wall. It has a roof, but no windows.
4. Recessed/inset enclosed balconies. This type of balcony has a roof and windows (which can be closed or openable).

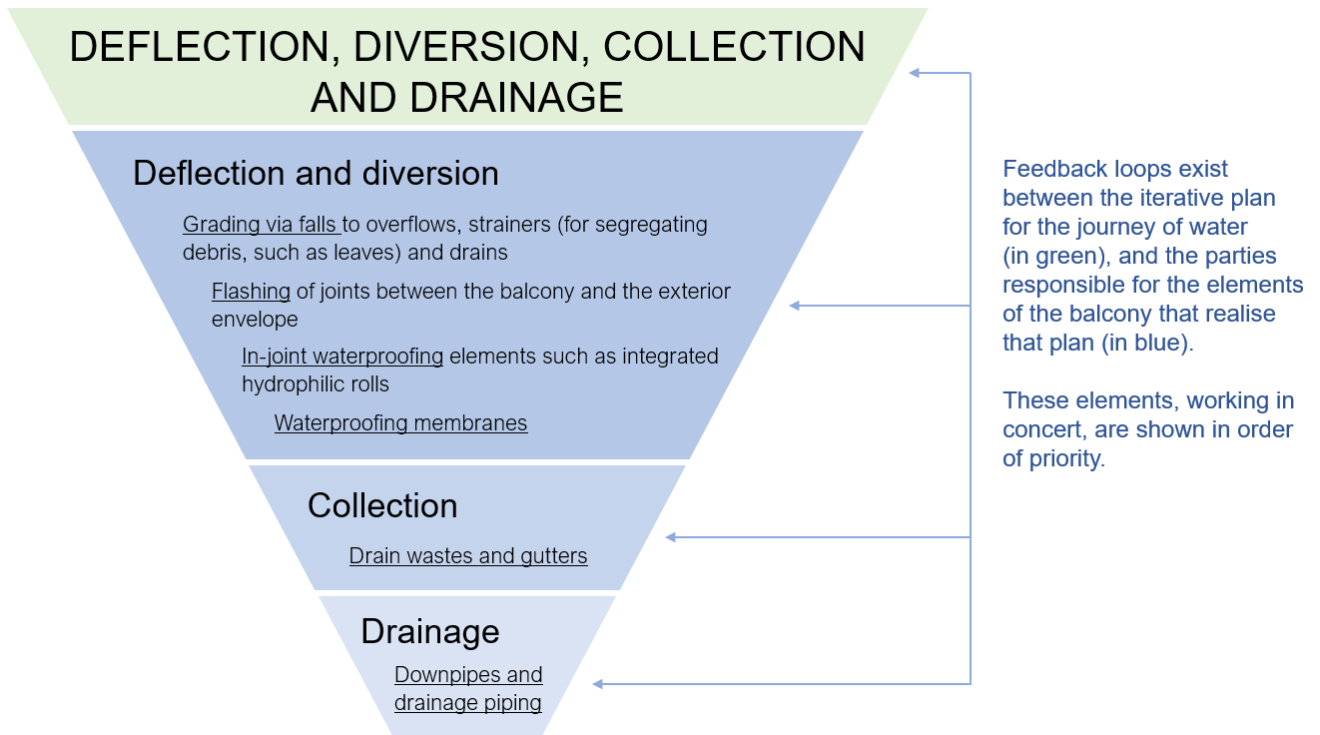
Figure 17: A clearly defined pathway for water to follow is imperative for concrete balconies

This perspective is best adopted across the whole-of-life of the balcony, and as such no one element of the balcony should be viewed as a singular waterproofing solution. Falls, flashing and in-joint waterproofing are essential tiers of protection that support waterproofing membranes. Currently available membranes have an estimated life of approximately 15 years or less, which is well below the length of building design life. Further, membranes are known to be vulnerable to separation and cracking due to movements of building elements (e.g. due to moving loads, wind, and thermal expansion and contraction). Therefore, concrete balcony designs must incorporate other pathways that are available for water to travel (e.g. in draining and collecting to defined points), as the balcony must continue to drain and shed water even when one element of the structure fails. This multi-tiered perspective of waterproofing measures is illustrated in Figure 17.

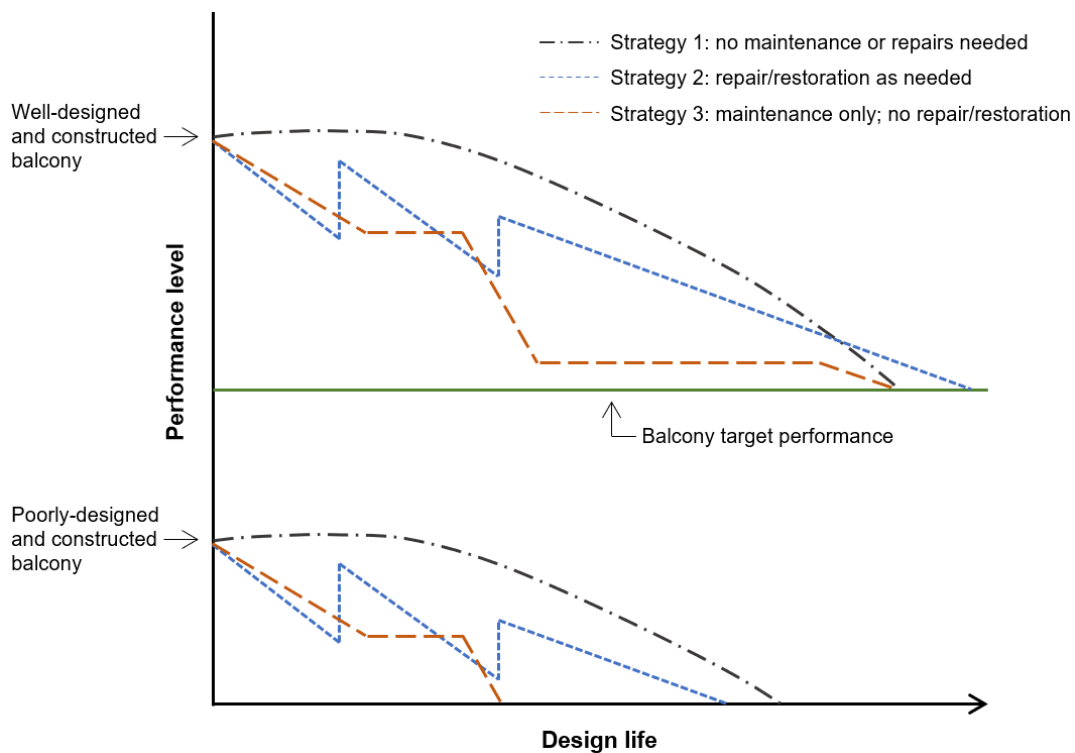
Figure 19: Life Cycle Performance: Authors' interpretation for concrete balconies

For the purpose of demonstrating the LCCA in the context of concrete balconies, and the benefits of its usage in decision making during design and construction, the authors have re-interpreted the LCP to show the impact of these three strategies as applied to well- and poorly-constructed balconies (Figure 19).

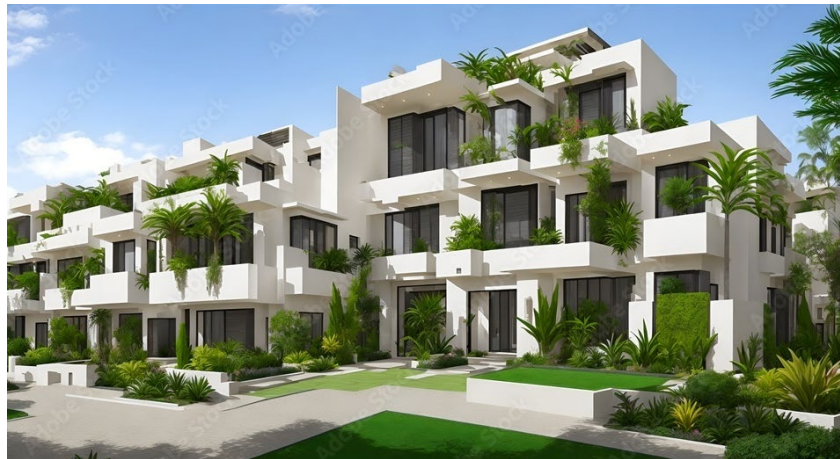
Figure 22: Balconies with plants, presenting the potential for heavy loading issues

Figure 22 highlights the potential for loading issues imposed by heavy pots and plants.

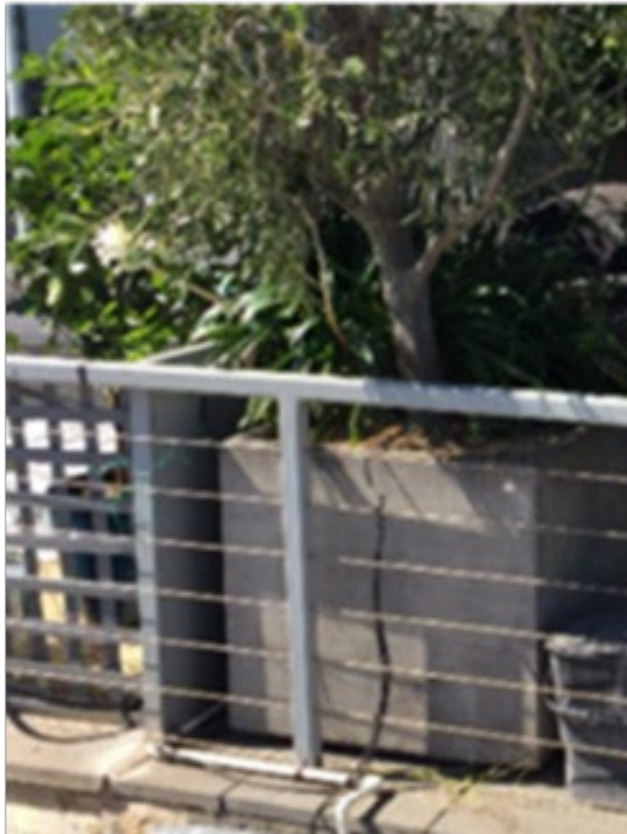
Figure 69: Defect - sagging of handrail (heavy loading)

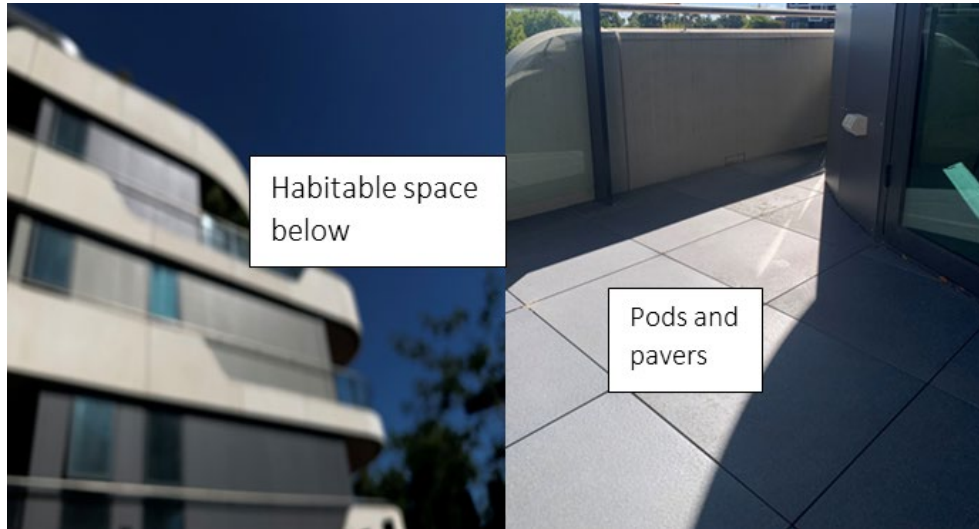
Figure 75: Case Study E - balcony construction
